**CORNER RECORD**

Document Number 2149

County of SACRAMENTO, California

Brief Legal Description LOT 1530, ARDEN PARK VISTA #11, 32-R.M.-3

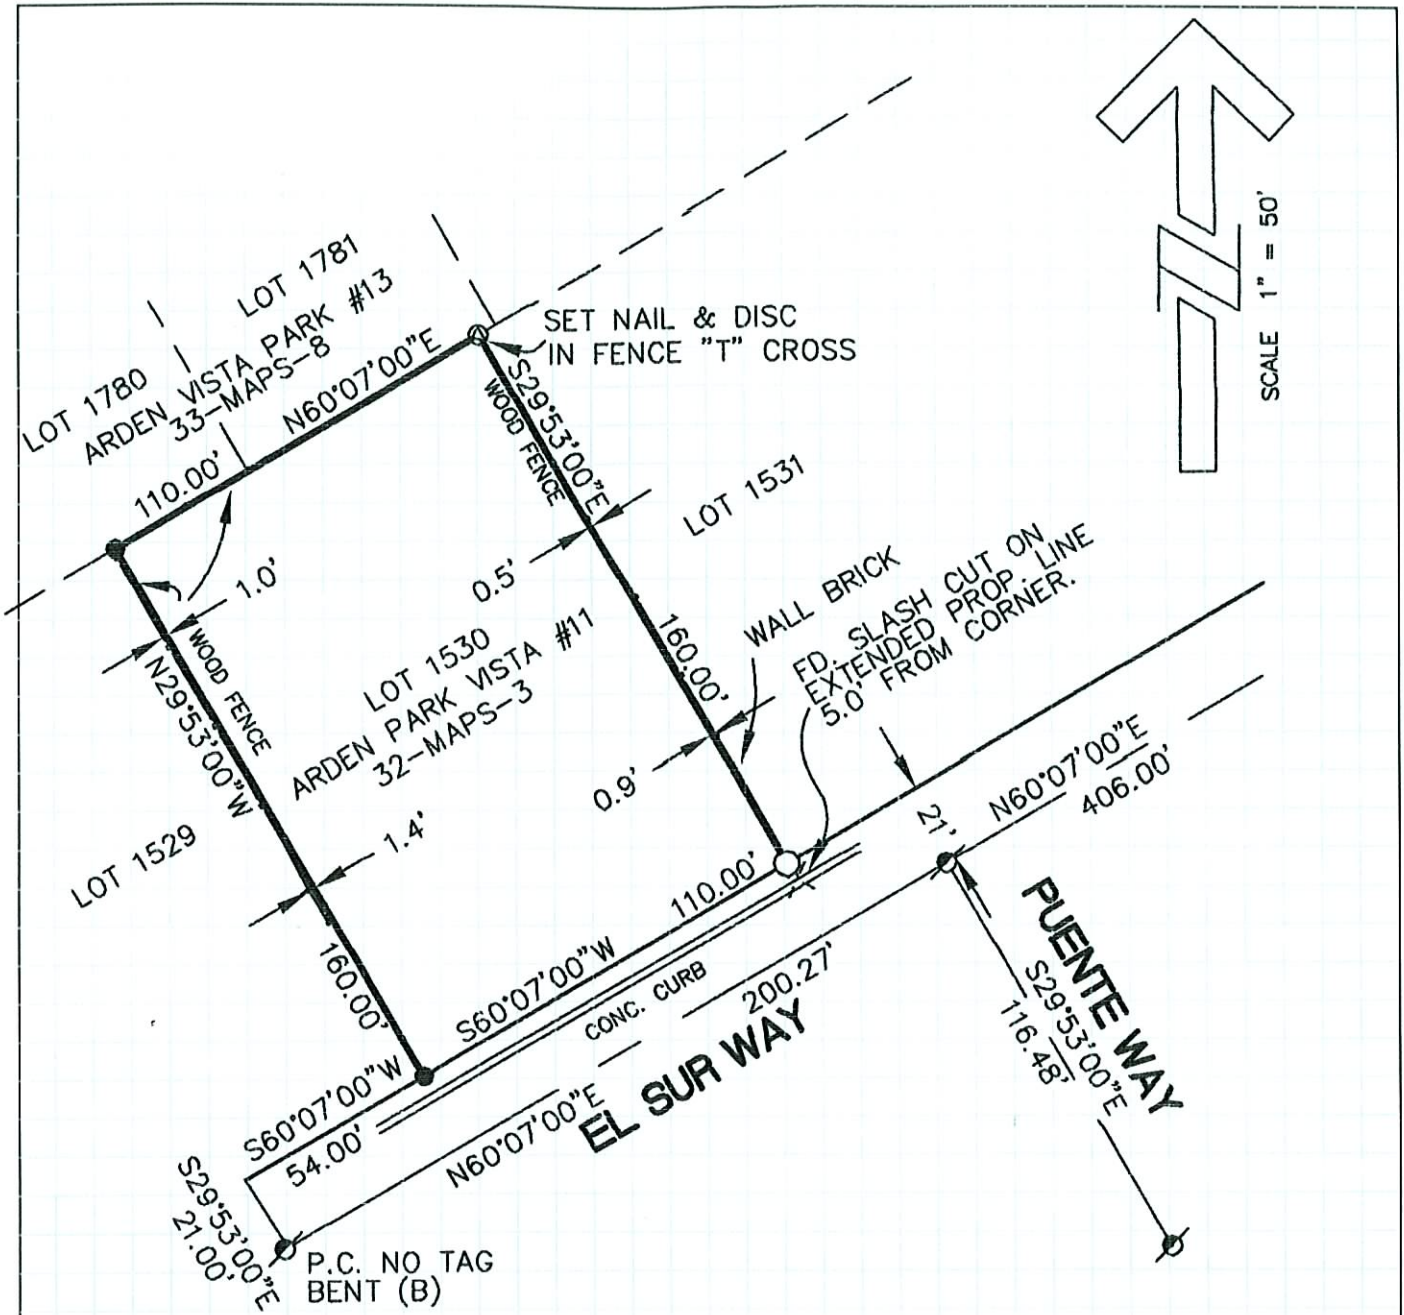
A description of the physical condition of the monument as found and as set or reset: MONUMENTS FOUND WERE IN GOOD SHAPE & AGREED WITH RECORD & POSSESSION. SET MARK WITH STAMPED DISC OR CAPTED REBAR AS SHOWN ON REVERSE SIDE.

ALL COURSES ARE MEASURED AND MATCH THE RECORD REFERENCES.
